Manhole Inspection Summary

Manhole # S63I__017MH

Insp Date: **5/13/08 10:28 AM**

Location Address: **5100 Eastern Blvd.**

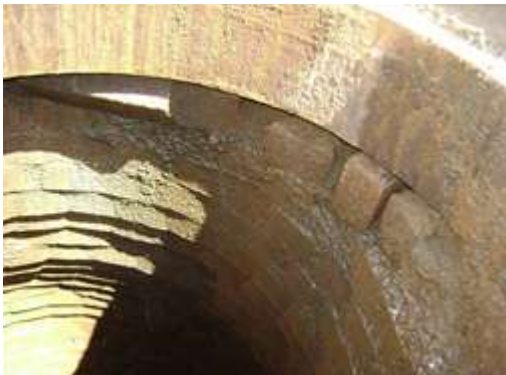
Defect 3

Infiltration: ☐ None ☒ **Joint** ☐ Cracks ☒ **Mortar** ☐ Roots ☐ Wall

Infiltration under frame

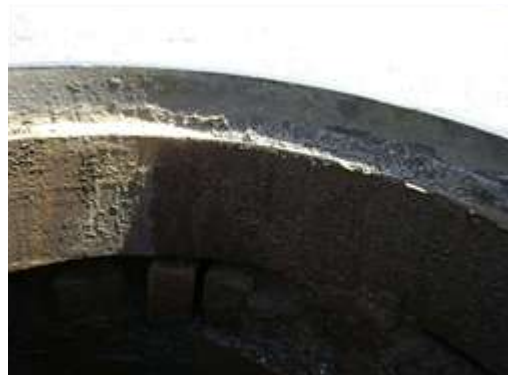
Defect 2

Condition: ☐ Sound ☐ Cracked ☐ Root Intrusion ☒ **Loose Brick** ☒ **Deteriorated**

Loose bricks under frame

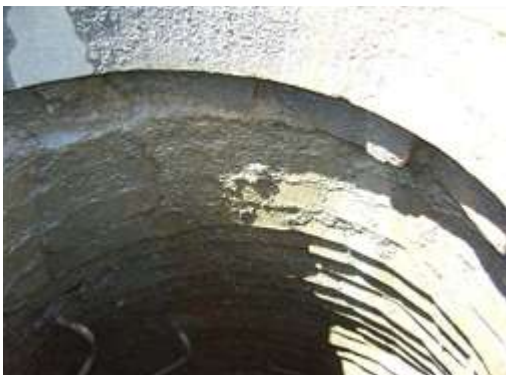
Defect 4

evidence of infiltration on chimney

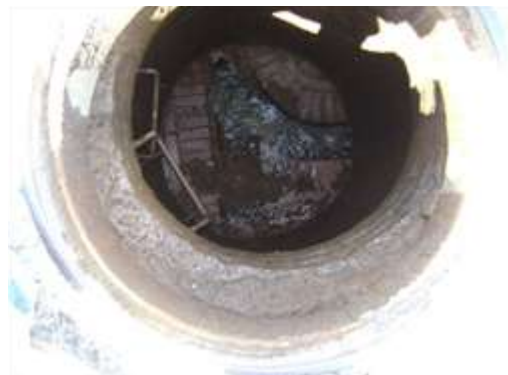
Defect 1

Offset: **3** (in.)

frame offset

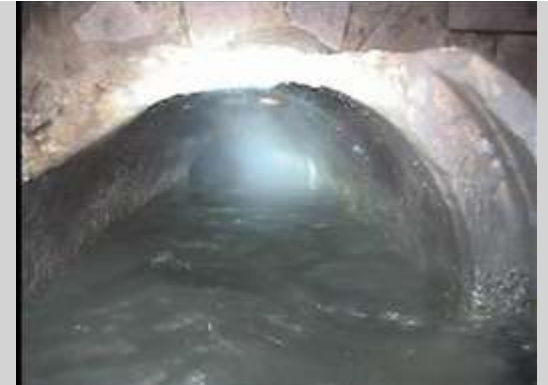
12 O'Clock Outflow

10 in. Circular Gravity Sewer
Pipe Out @ 12 O'Clock

Pipe Height: **9.6** (in.) Rod and Bar (Angled)
Pipe Material: **Clay** ☐ Pipe Lined
Invert Depth: **9.33** (ft.) Flow Characteristics: **Fast**
Deposits: ☒ None ☐ Mud ☐ Sludge ☐ Debris ☐ Grease
Silt Depth: (in.) Deposits Extent:
Infiltration: **None** Pipe Seal Cond: **Sound**

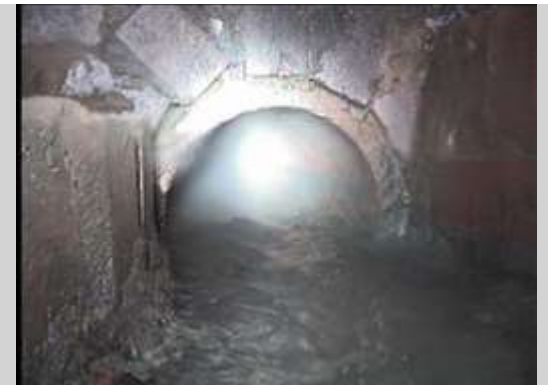
3 O'Clock Inflow

8 in. Circular Gravity Sewer
Pipe In @ 3 O'Clock

Pipe Height: **8.4** (in.) Rod and Bar (Angled)
Pipe Material: **Clay** ☐ Pipe Lined
Invert Depth: **9.17** (ft.) Flow Characteristics: **Fast**
Deposits: ☒ None ☐ Mud ☐ Sludge ☐ Debris ☐ Grease
Silt Depth: (in.) Deposits Extent:
Infiltration: **None** Pipe Seal Cond: **Sound**

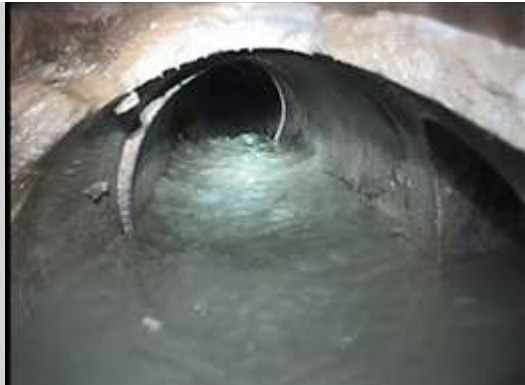
6 O'Clock Inflow

10 in. Circular Gravity Sewer
Pipe In @ 6 O'Clock

Invert Depth: **9.26** (ft.) Flow Characteristics: **Turbulent**

Infiltration: **None** Pipe Seal Cond: **Sound**
